The Effect of Aging on the Fatigue Strength of Alloy 800HT

A Thesis Presented to the

MECHANICAL ENGINEERING

September, 1999

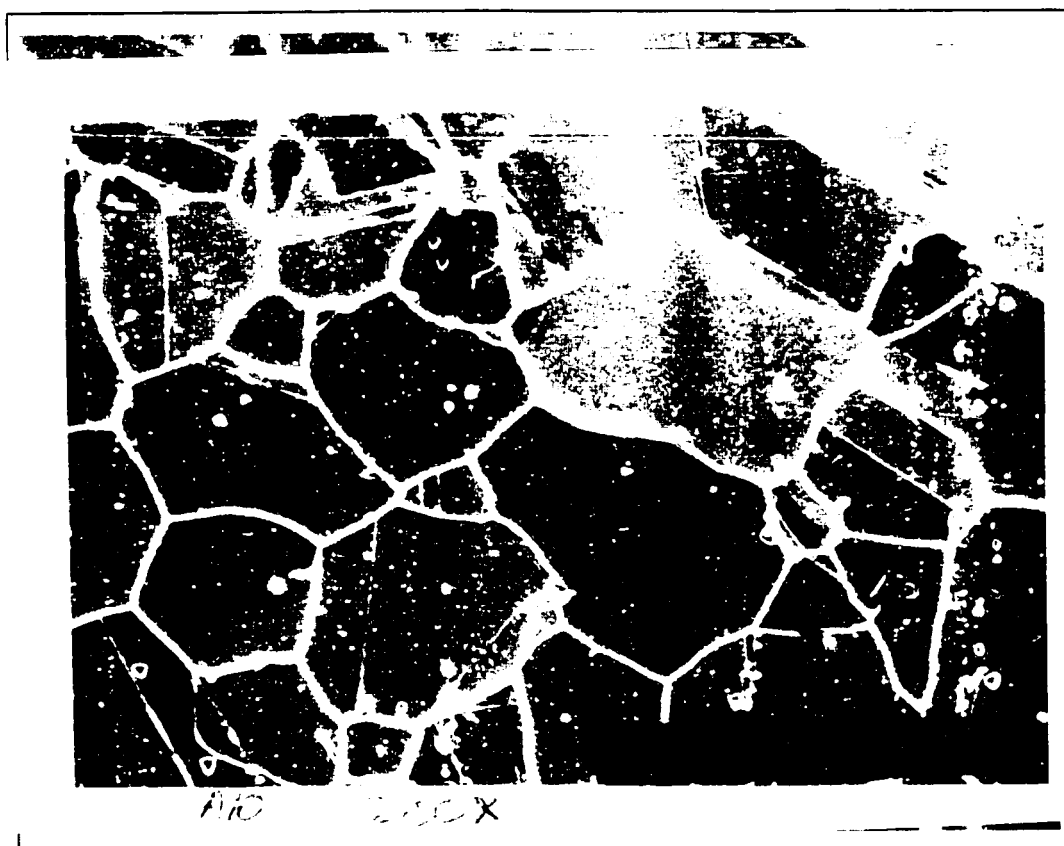
Figure 21: Micrograph of specimen aged at 650°C for 1000 hours (200X). A fine network of grain boundary carbide precipitates (A) with small amounts of intragranular carbides (B). Discontinuous twin boundary carbide network (C and D).
